STEELS FOR SOUR SERVICE: RESEARCH IN ESCOLA POLITÉCNICA, UNIVERSITY OF SÃO PAULO (EPUSP)

N. Alonso-Falleiros

USP (University of Sao Paulo); Av. Prof. Mello Moraes, 2463; Sao Paulo; SP, 05508-030, Brazil

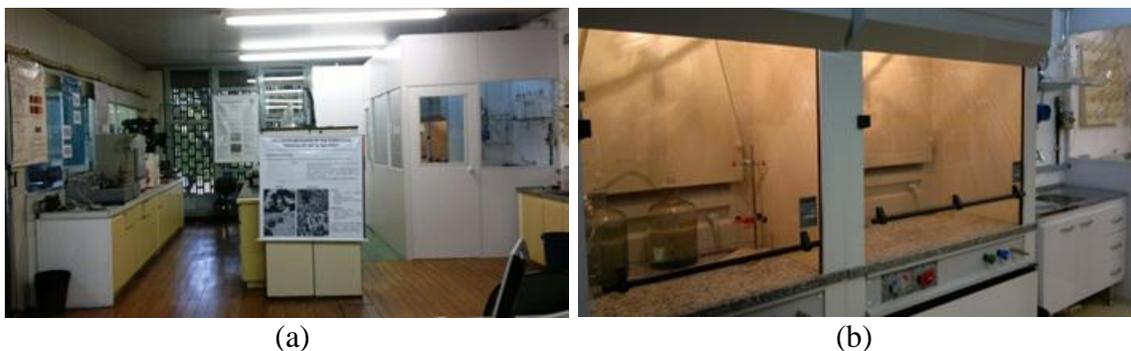
Figure 1. (a) Overview of LabH₂S, (b) Safety cabinet for experiments with special gases.

A recent improvement in the Department has been the construction of a new facility coupled to the “Electrochemical Processes Laboratory” (LPE/-PMT) that has potentiostats and other resources used in electrochemical tests, which has been operating since 1991, the year of the acquisition of the first potentiostat. The "Laboratory of H₂S - Tests with Special Gases" (LabH₂S), Figure 1, was built as part of a research project, sponsored by CBMM, and was opened on 2nd December, 2011.

H₂S gas, used in most of the experiments carried out in this laboratory, has an unpleasant smell and is dangerous to human health and to the environment. Its handling requires special procedures for the safety of users and for the disposal of exhaust gases to the environment. During the planning of the laboratory, there was a constant focus on safety. The facilities feature a gas injection panel with flow control, isolated safety cabinet connected to a chemical scrubber for gas cleaning and neutralization, controlled temperature environment, electrical safety outlets, anti-explosion lighting and light and sound alarms to detect gas leaks.

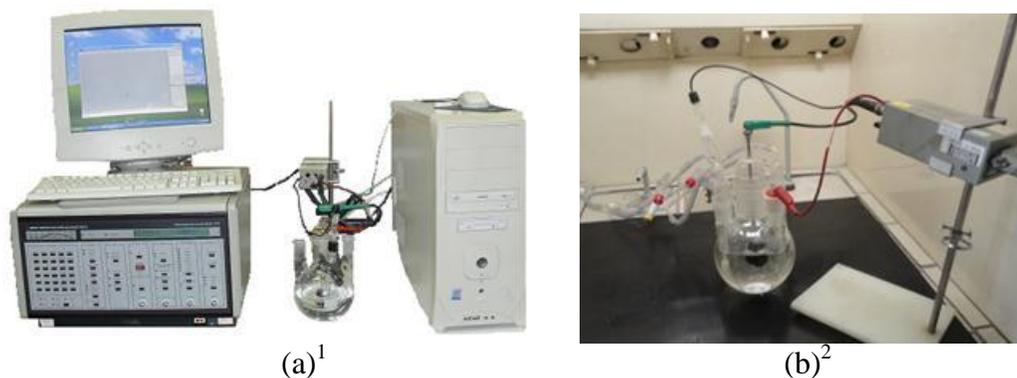
Figure 2. Electrochemical test; (a) Potentiostat PAR 273A, (b) Electrochemical cell.

Ongoing research activities include, for instance, studies of experimental methods for measuring corrosion resistance: weight loss and electrochemical tests with the use of potentiostats, Figure 2; evaluation of the influence of inclusions on the morphology of corrosion - uniform and/or

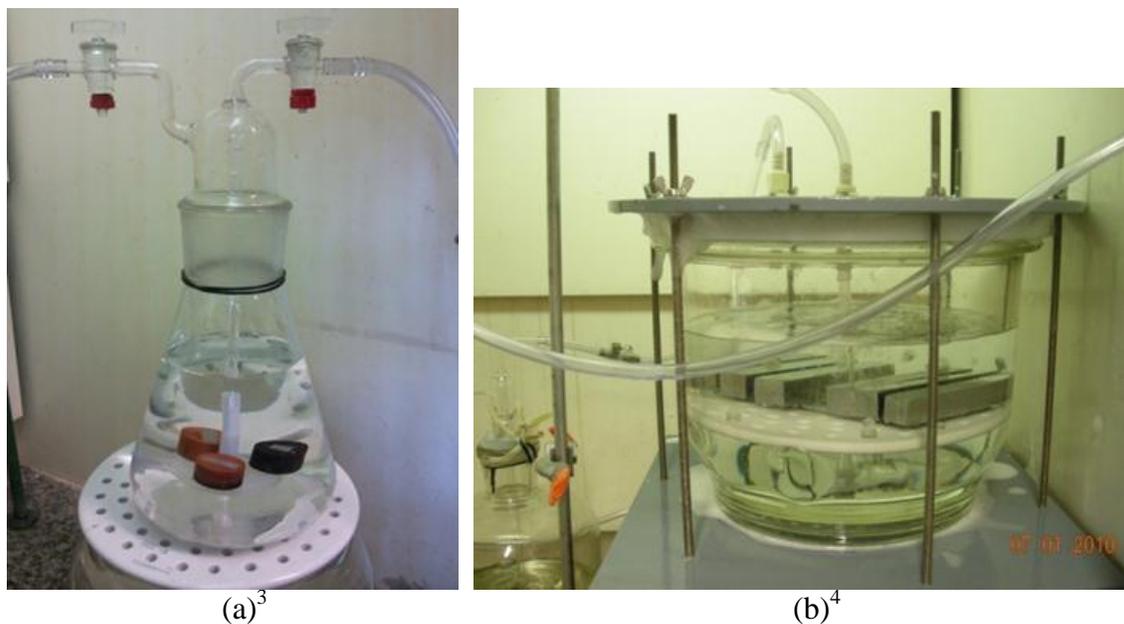
Figure 3. (a) Immersion test to examine corrosion morphology, (b) Hydrogen induced cracking test, according to NACE TM0284-2003.

localized, Figure 3a, through immersion tests of polished samples, with tests and analysis in a scanning electron microscope (SEM) and analysis by energy dispersive spectroscopy (EDS); tests of Hydrogen Induced Cracking (HIC) in API 5L X65 and X80 pipes according to NACE TM0284-2003 standard, Figure 3b, and examination by optical microscopy and SEM. In all cases, microstructural observations are aimed at understanding the cracking and corrosion mechanisms.

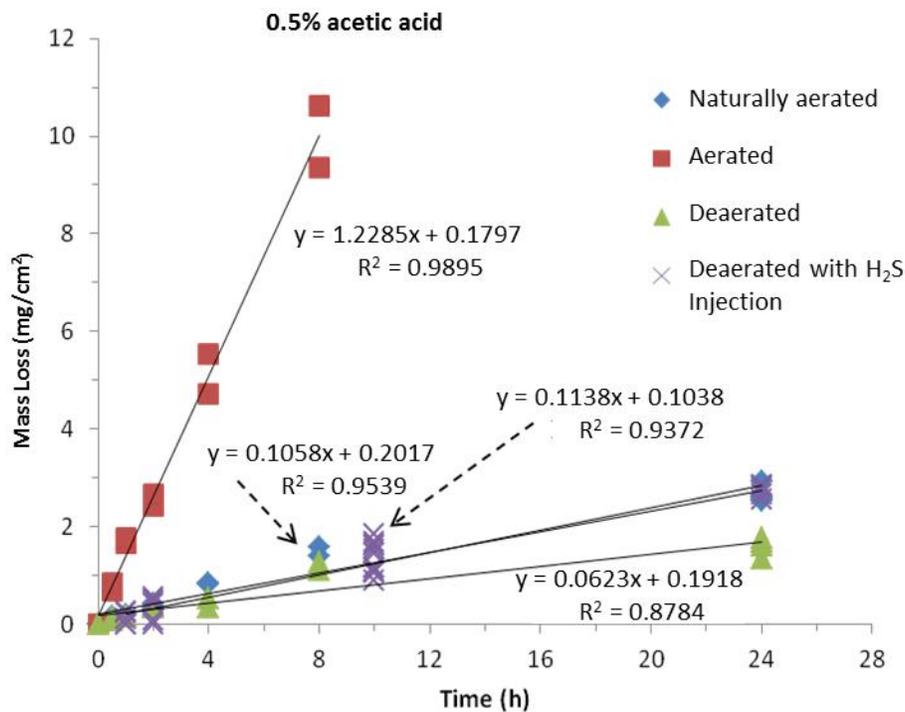
Figure 4. Mass loss in 0.5% acetic acid in different conditions: Naturally aerated solution; Aerated solution; Deaerated solution; Deaerated solution with H₂S injection [1].

Mass loss, Figure 4, and potentiodynamic tests, Figure 5, were performed in different media, in the presence or absence of H₂S for a steel that is used for API 5L X80 pipe production. Mass loss tests showed that dissolved oxygen in aqueous media accelerates the kinetics of uniform corrosion. Deaerated media, with or without addition of H₂S, is much less corrosive. Potentiodynamic polarization curves did not show differences, indicating that this procedure is not suitable for the determination of differences in the corrosion rates. On the other hand, the determination of polarization resistance (R_p) agreed with the results of mass loss experiments, as shown in Figures 4 and 6.

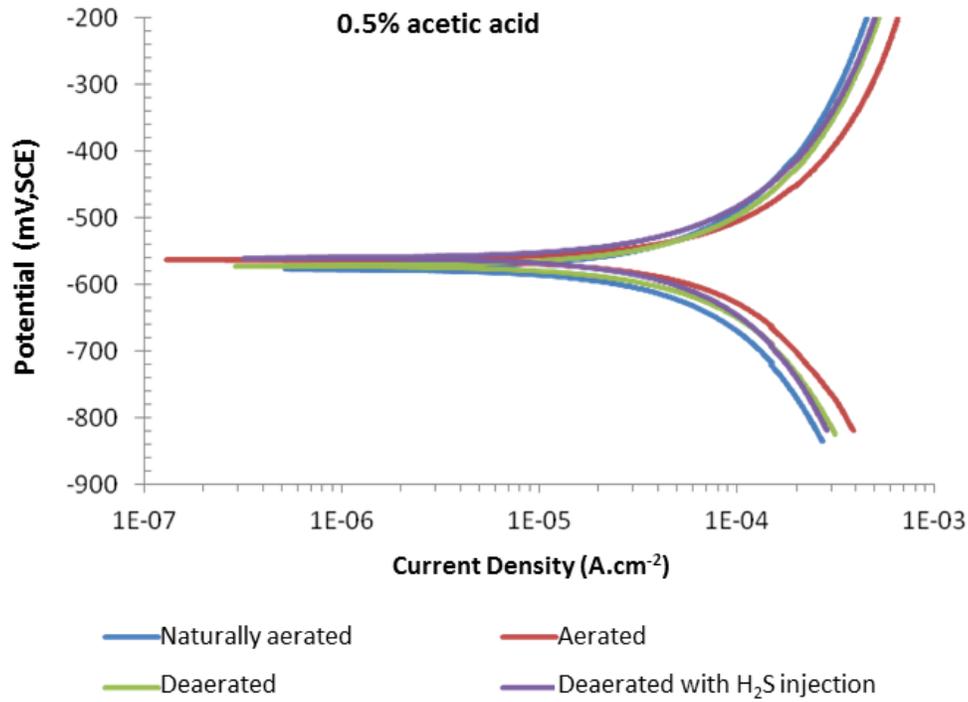
Figure 5. Potentiodynamic curves in 0.5% acetic acid in different conditions: Naturally aerated solution; Aerated solution; Deaerated solution; Deaerated solution with H₂S injection [1]. SCE: Saturated Calomel Electrode.

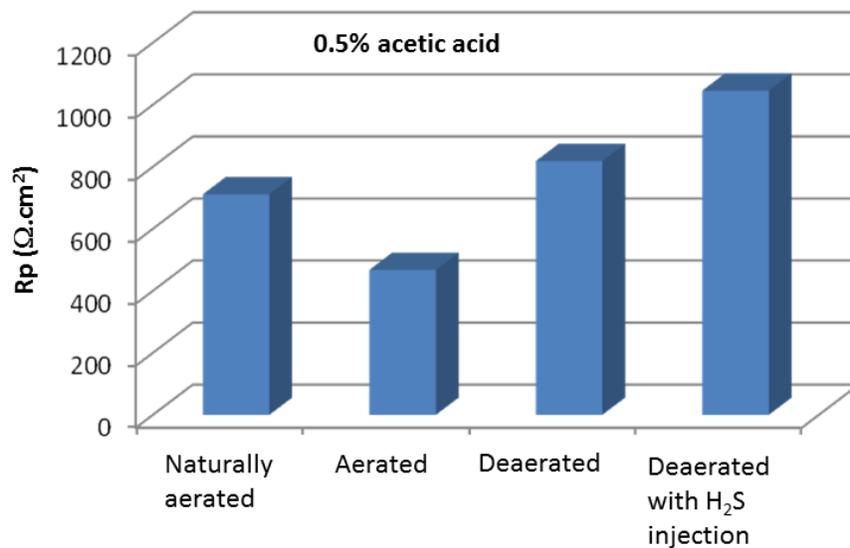
Figure 6. Polarization resistance (Rp) values in 0.5% acetic acid in different conditions: Naturally aerated solution; Aerated solution; Deaerated solution; Deaerated solution with H₂S injection [1].

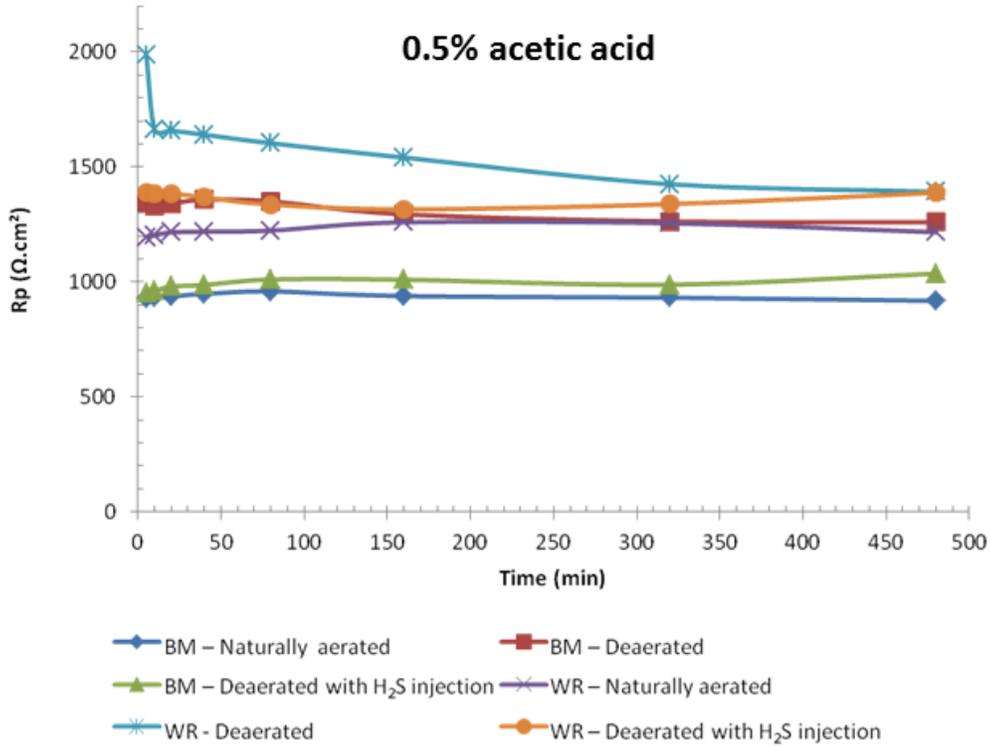
Figure 7. R_p values for different samples of API 5L X80 pipe material in different conditions as a function of immersion time in 0.5% acetic acid. BM: base metal; WR: weld region [2].

Results of another study [2], for API 5L X80 pipe material, showed that R_p did not change significantly with the immersion time up to 8h, Figure 7. With this information, the evaluation of corrosion resistance of HSLA steels is now determined by R_p values for immersion times up to 60 minutes only, making the procedure faster.

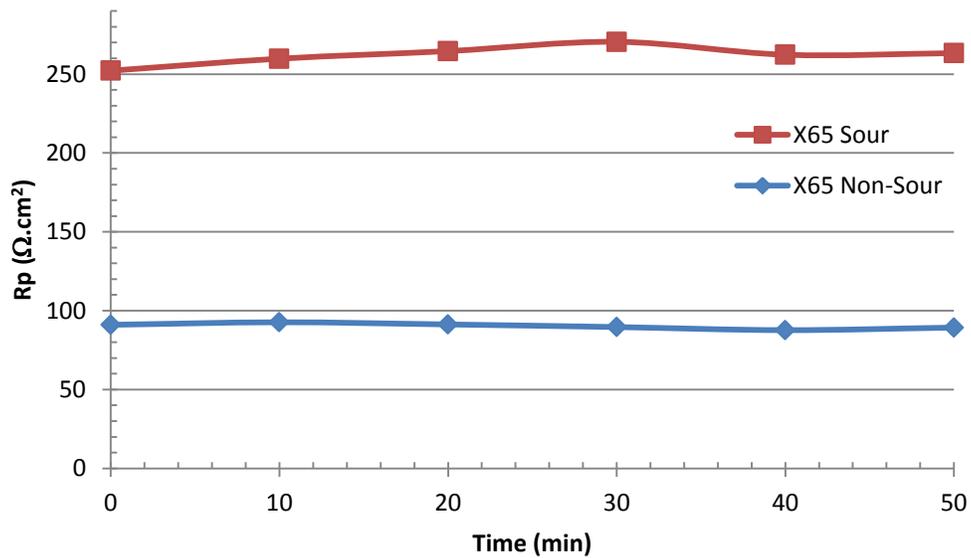
Figure 8. Polarization resistance as a function of immersion time in solution A of the TM0284-2003 standard. Comparison of non-sour and sour service pipes [3].

The method of polarization resistance showed that the steels designed for sour service have better corrosion resistance, Figure 8 [3]. Samples of API 5L X65 pipe material for sour and non-sour service were tested by the polarization resistance method in solution A of NACE TM0284-2003 standard (with injection of H₂S). Results showed similar corrosion morphology in both steels, with preferential corrosion at metal-inclusion interfaces as shown in Figures 9 and 10. The R_p values, as well as the microscopic examination, indicate better corrosion resistance for the sour material, possibly due to the different chemical compositions of the steels and different inclusion densities.

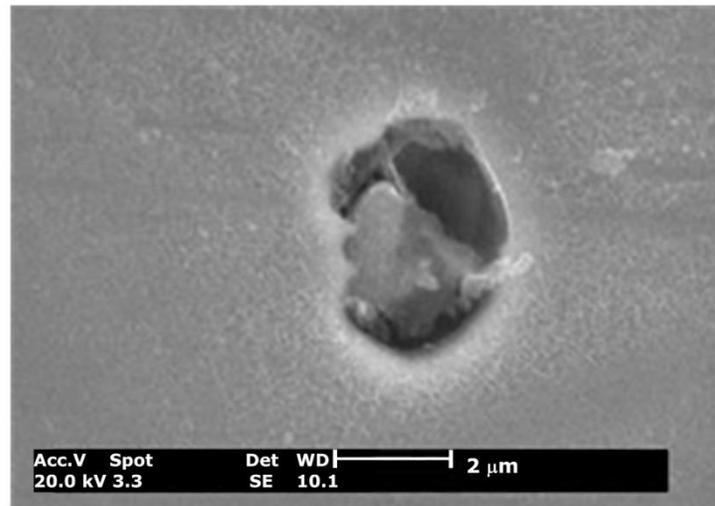
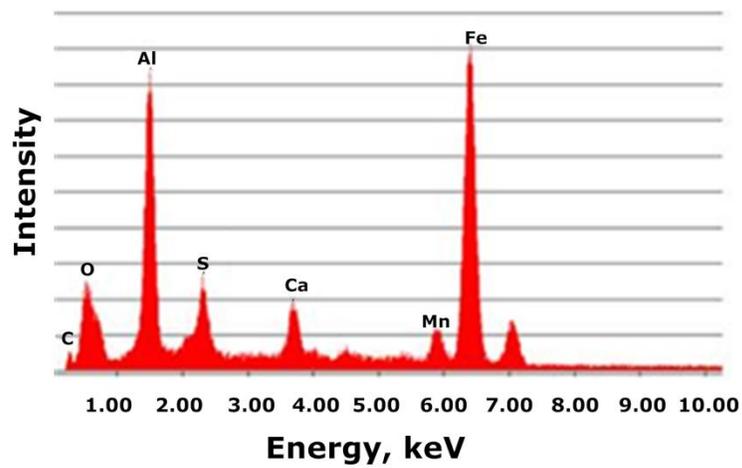
Figure 9. (a) Example of an inclusion present in the X65 sour pipe material and (b) its corresponding EDS chemical analysis. EDS analysis shows the presence of Al, Ca, S, Mn and Fe [3].

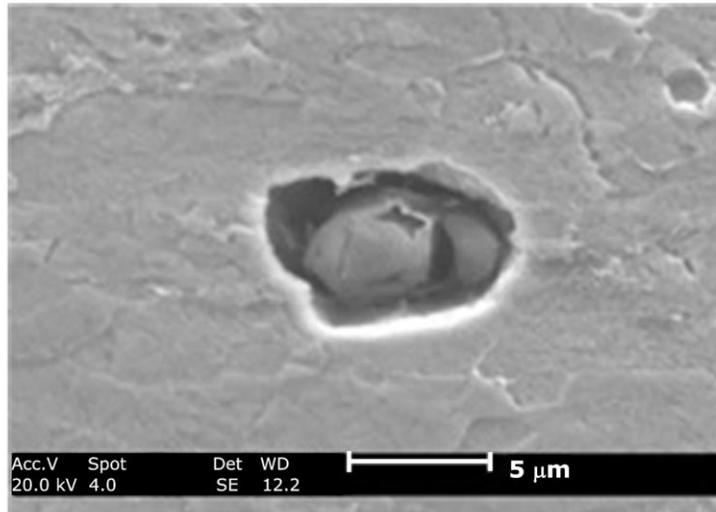
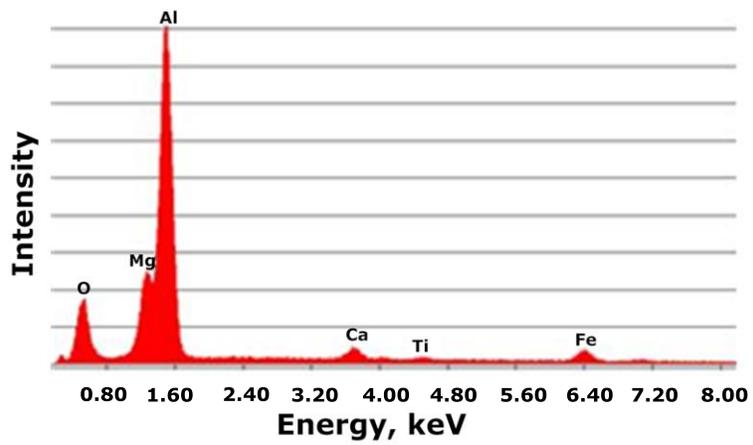
Figure 10. (a) Corrosion around an inclusion in the X65 non-sour pipe after immersion test, (b) EDS analysis shows the presence of Al, Mg and Ca [3].

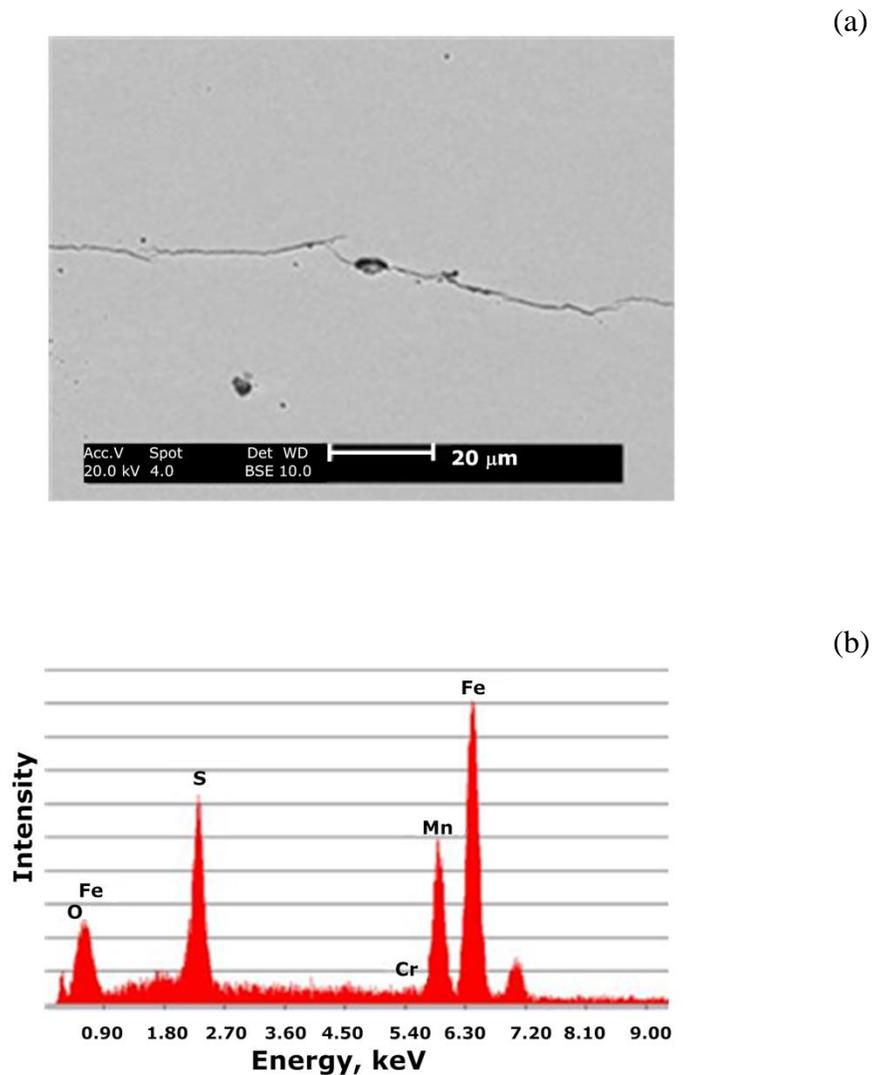
Figure 11. (a) Inclusions on the crack path in X80 specimen, (b) Corresponding EDS analysis showing the presence of manganese and sulphur [4].

API 5L X80 and API 5L X65 pipe materials were compared [4] with regards to hydrogen exposure in a corrosive environment in the presence of H₂S (solution A - NACE TM0284-2003). The results show that the X80 pipe, Figure 11, is more susceptible to hydrogen induced cracking than the X65 [4]. X65 pipe material did not show any cracking. Elongated MnS inclusions are sites of crack nucleation while other types of inclusions can help crack propagation. Moreover, rounded inclusions can also nucleate cracks but are thought to be less susceptible to crack nucleation. Inclusion shape control is done in steelmaking by several processes, many of them using Ca treatment. Possibly this is the origin of the Ca detected by EDS analysis, Figures 9b and 10b. Inclusion shape control is not the only way to increase API 5L tubes HIC resistance. Microstructure control is also important for crack nucleation and propagation.

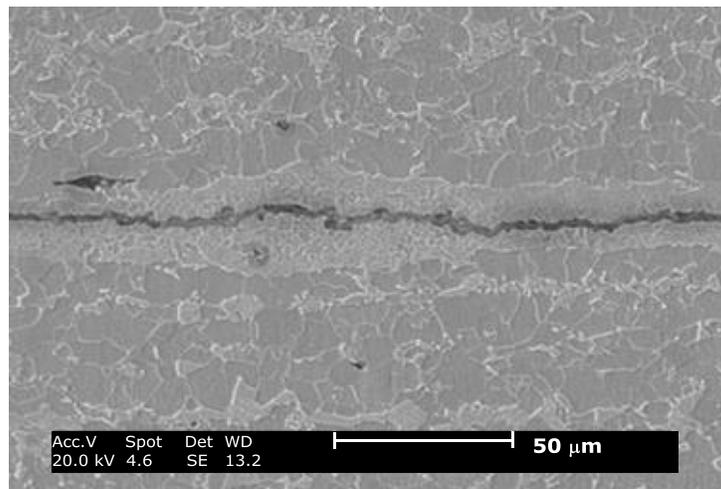
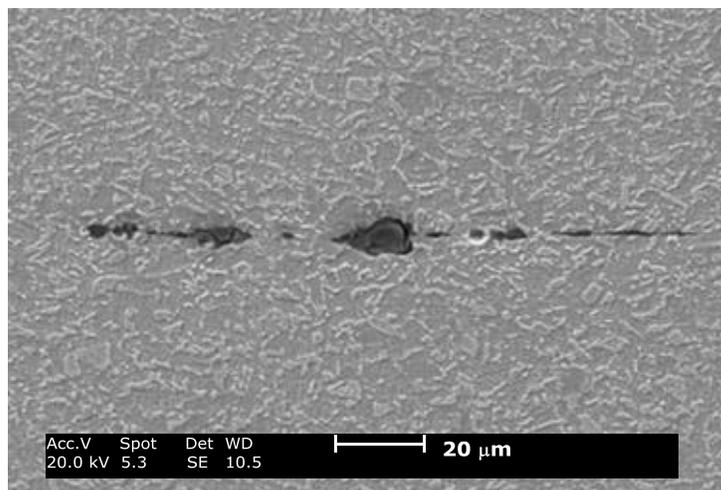
(a) $0.5\text{ }^{\circ}\text{C}\text{s}^{-1}$

(b) $10\text{ }^{\circ}\text{C}\text{s}^{-1}$

Figure 12. Microstructure of samples subjected to different cooling rates and hydrogen induced cracking test [5].

The effect of different microstructures on hydrogen induced cracking of microalloyed steels, austenitized and subjected to different cooling rates, was studied [5]. Samples extracted from a plate and heat treated in a quenching dilatometer were subjected to hydrogen induced cracking tests (NACE TM0284-2003). Slow cooled samples (cooling rate of $0.5\text{ }^{\circ}\text{C}\text{s}^{-1}$) showed higher susceptibility to hydrogen induced cracking, with large cracks in the middle of the sample, propagating along segregation bands at the centerline of the plate thickness, as shown in Figure 12a. For cooling rates of $10\text{ }^{\circ}\text{C}\text{s}^{-1}$ and $40\text{ }^{\circ}\text{C}\text{s}^{-1}$, only small cracks were found in the matrix and micro-cracks nucleated at non-metallic inclusions, as shown in Figure 12b.

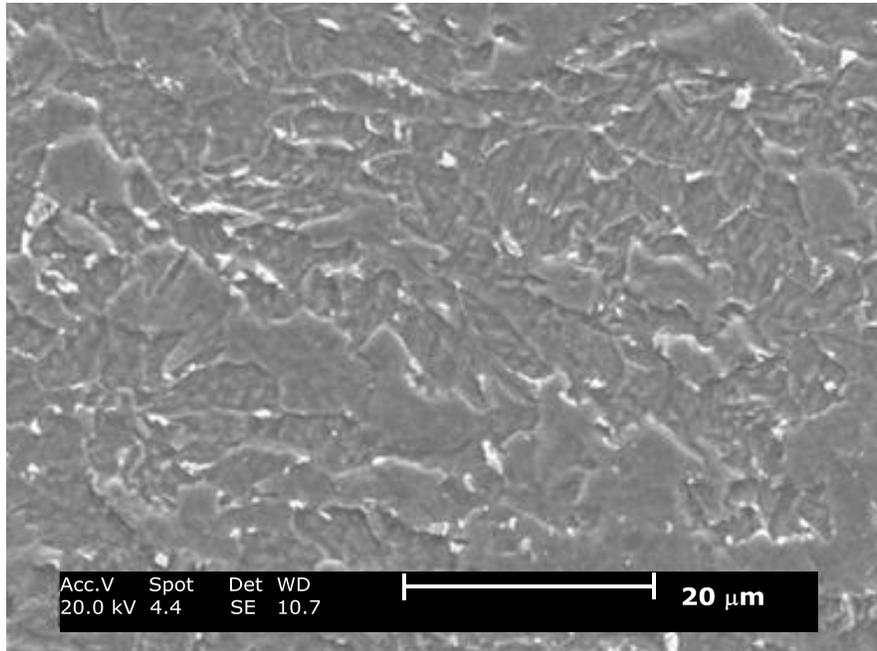
Figure 13. Secondary electron image. Granular ferritic matrix, acicular ferrite and micro-constituent MA. Etchant: Nital 2% [6].

On the other hand, the hydrogen induced cracking process in the API 5L X65 pipe material related to the micro-constituents; no relation to the inclusions was observed [6]. The materials with granular and acicular ferrite microstructure and microconstituent MA, Figure 13, were immune to hydrogen induced cracking in tests made in solutions A and B NACE TM0284-2003, while those with banded microstructures of alternating ferrite and pearlite had cracks, Figure 14.

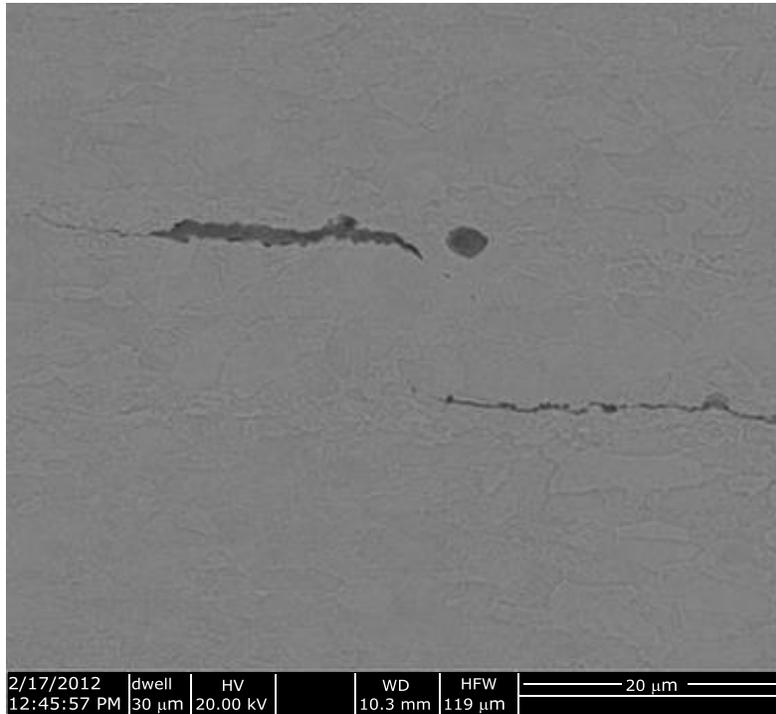
Figure 14. Backscattered electron image of a crack nucleated in the segregation band. Etchant: Nital 2%. Solution A - NACE TM0284-2003. Ferrite and pearlite microstructure [6].
