OVERVIEW ON 718Plus® ASSESSMENT WITHIN “VITAL” PROJECT

Keywords: 718Plus, structures, high temperature exposure, VITAL R&D

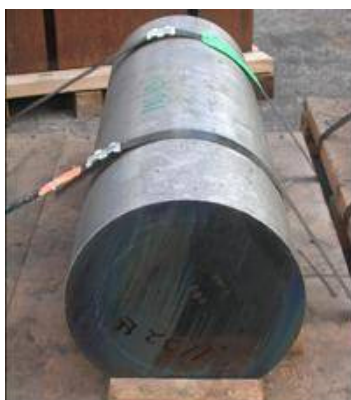
Figure 1: 304.8 mm billet used for production of forged rings at Forgital.

Several rings were rolled by Forgital, Italy, to assess the forgeability of 718Plus from Allvac 304.8 mm billet, see Figure 1. Chemical composition of this particular heat is given in Table 1, in weight percent. Smaller diameter pieces (from 203.2 mm down to 101.6 mm diameter) from the same heat were used for different purposes, including remelt stock to produce cast parts.

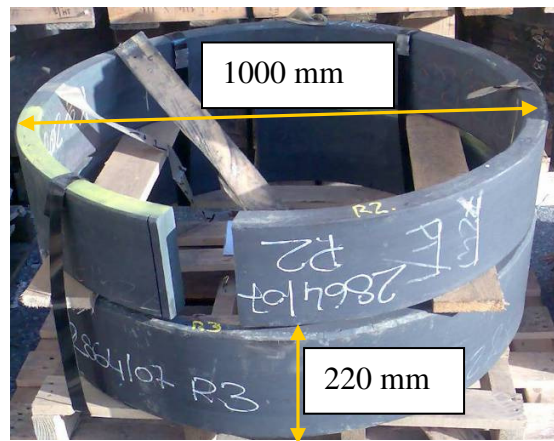
Figure 2: Rings 2 and 3 after forge at Forgital.

Production of the rings was performed following previous experience at the forging shop with rings in 718 alloy. Rings' dimensions are shown in Table 2, and Figure 2 shows representative forgings sent for evaluation and mechanical testing. The upper one shows a cut from where material was excised for preliminary microstructural assessment before heat treatment. The same rolling temperatures, number of reheats and other values of forging parameters for these rings in 718 alloy were used. First rolling was at 1110°C, and final rolling at 1010°C. First rolling was given with 4 heats for rings 1– A and 2, and 2 heats for rings 3 and 4 – B. Final rolling was given with 3 heats for all rings. Although most of the process was performed successfully, some cracks at the corners of the rings appeared during rolling, as can be seen in Figure 3. These indicate that the manufacturing process needs to be modified, and that those 718 alloy forging parameters cannot be directly applied for the new 718Plus if a totally sound product is expected to be obtained from the manufacturing process.

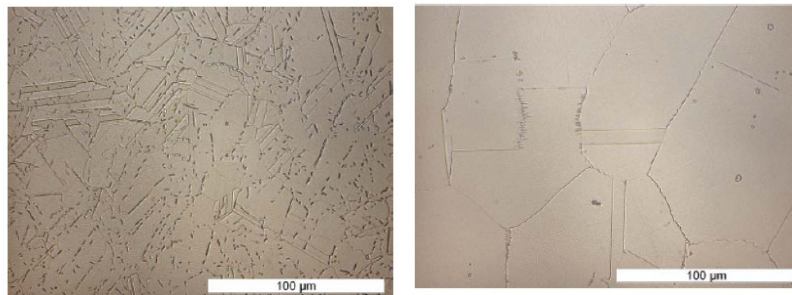
Figure 4: Microstructure of as rolled rings, representing rings (1-A and 2) ASTM8 grain size, δ phase (left), and rings (3 and 4-B) ASTM5 grain size, little δ (right).

The different geometries and manufacturing routes of the rings resulted in quite different microstructures. The grain size of rings 1 - A and 2 (thicker, shorter ones) was ASTM8 while the grain size of rings 3 and 4 - B (thinner, taller ones) was ASTM5. Rings 3 and 4 - B had an additional reheat at 1010°C, which resulted in this larger grain size. At the same time, a lower amount of δ phase was also noticed. Figure 4 shows these differences.

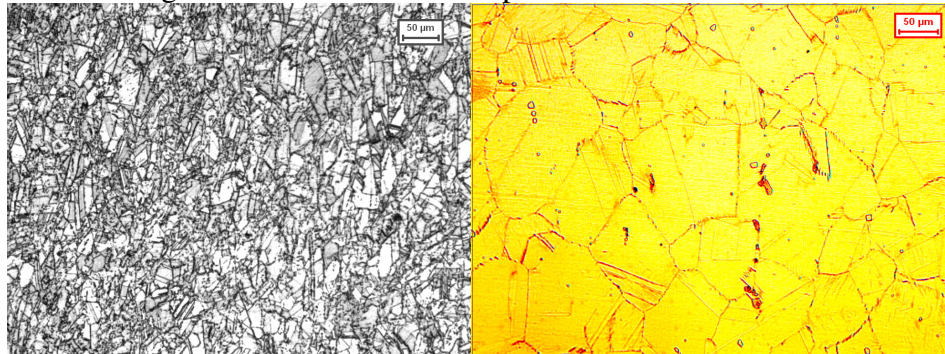
Figure 5: Micrographs of heat treated rolled rings thicker rings (1-A and 2) ASTM8 grain size, δ phase (left), and thinner rings (3 and 4-B) ASTM5 grain size, no δ , (right).

Figure 5 shows the resulting microstructure after complete heat treatment of both sets of rings.

For wrought 718Plus alloy, analyses were also made on both fine grain and coarse grain materials, and also showed the noticeable increase in δ phase precipitation, see Figure 15 and compare with Figure 5, for material in the as-heat treated condition.

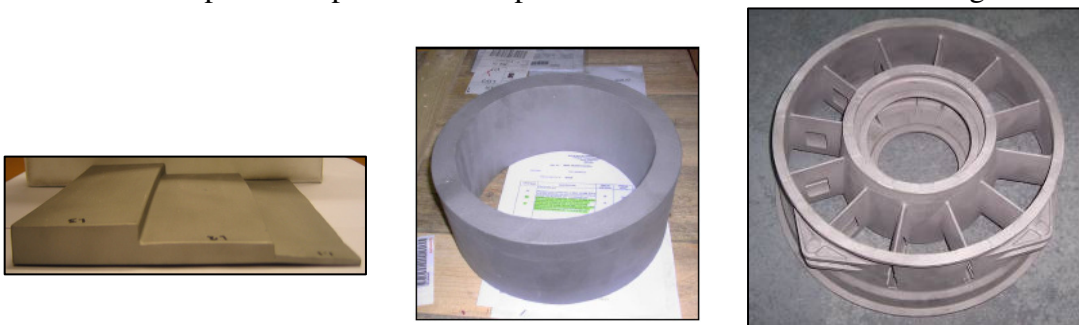
Figure 6: Stair shaped cast plates(left); hollow cylinders (centre); democast (right).

Casting trials were completed at PCB, Precicast Bilbao, Spain, to assess the feasibility of producing cast parts from this alloy. Trials included production of Separately Cast Test Bars, stair shaped cast plates for repair welding evaluation [10], hollow cylinders for mechanical testing, and a demonstration cast part, designed in a previous European R&D project [3]. This particular geometry includes different vane thicknesses, fillet radii, lugs and various local features that resemble usual features in structural components of aeroengine turbines. Figure 6 shows some of these produced parts. Table 3 provides dimensions of these castings.

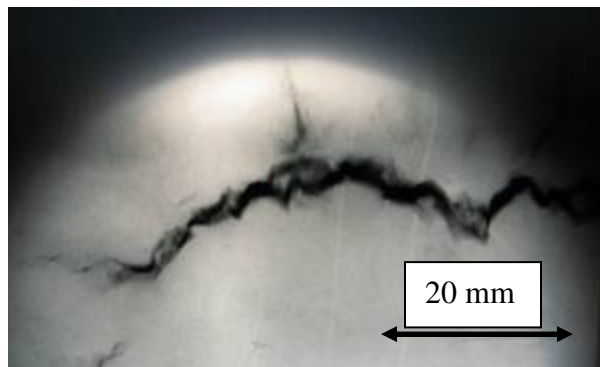
Figure 7: Morphology of cracks at thin areas of demonstration casting, as seen on X-ray plates.

Thickness as low as 1,4 mm were placed on areas of the democast, but no misruns were detected, so the alloy has proved not to be prone to rapid solidification which would inhibit fill of thin sections. Some cracks were detected in thin areas located away from the feeding system between other thicker areas. It seems that the faster cooling and solidification of these areas has been followed by the stresses imposed by the adjacent thicker areas due to shrinkage or contraction during solidification (lasting longer in those thicker areas). The lower load resistance capacity of the thin areas has then resulted in cracking by a hot-tearing mechanism, see Figure 7. It was considered that the gating system was too heavy for the part, but subsequent development of the casting process would be capable of achieving much better results.

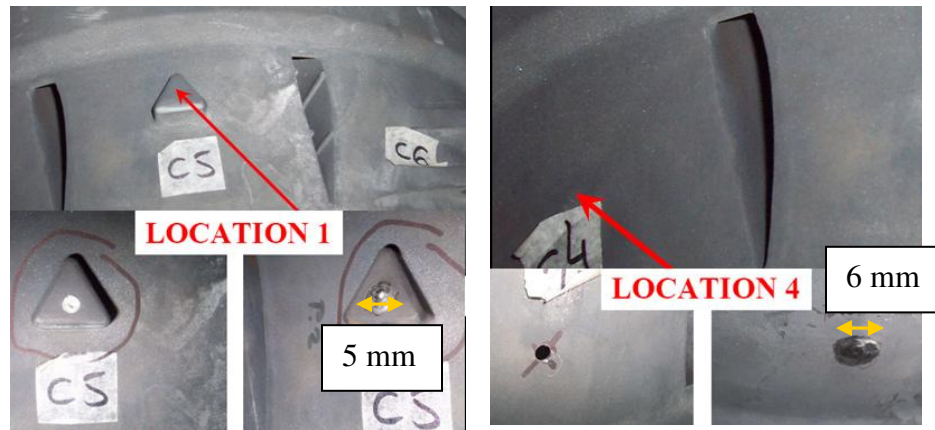
Figure 8: Weld repair trials performed on democast.

In addition to the weld repair assessment performed on cast plates [10], some weld repair trials were also successfully completed on the democast, covering different features and thicknesses, see Figure 8. These were made by TIG welding using 1.2 mm diameter filler material supplied by Allvac. The part was welded in the as-HIPed condition, prior to solution heat treat to demonstrate the feasibility of completing this kind of operation, typically required for manufacture of complex castings.

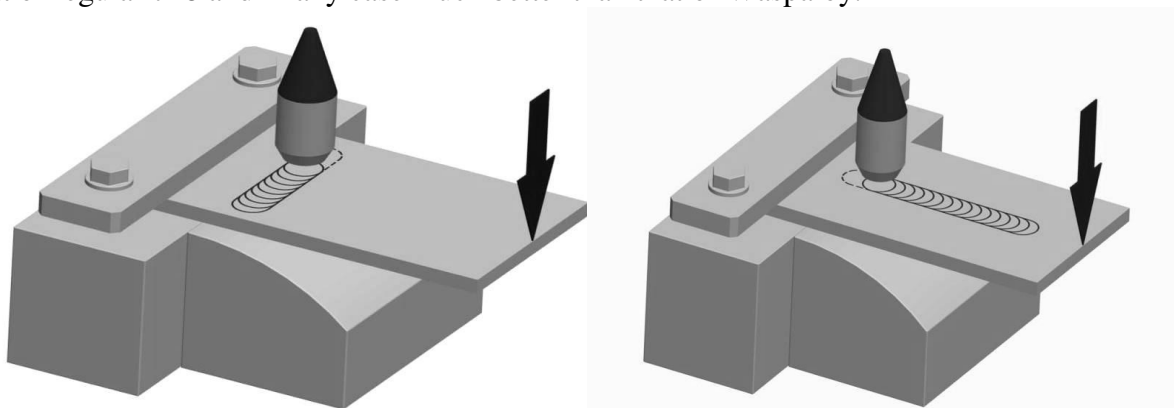
Figure 9: Schematic overview of TransVarestraint (left) and Varestraint (right) testing methods.

Initial assessment of 718Plus weldability was performed through Varestraint and TransVarestraint testing on sheet material. These two different tests are intended to evaluate how prone the alloy is to HAZ cracking and solidification cracking, respectively. By imposing various strains during the welding by bending test samples at the same time, it is possible to assess the propensity for cracking. This propensity is usually measured as the total amount of cracking that can be measured after weld operations performed in fixtures such as those depicted in Figure 9. Details on these results are given elsewhere [12], but generally indicate that weldability is comparable to that of regular 718 and in any case much better than that of Waspaloy.

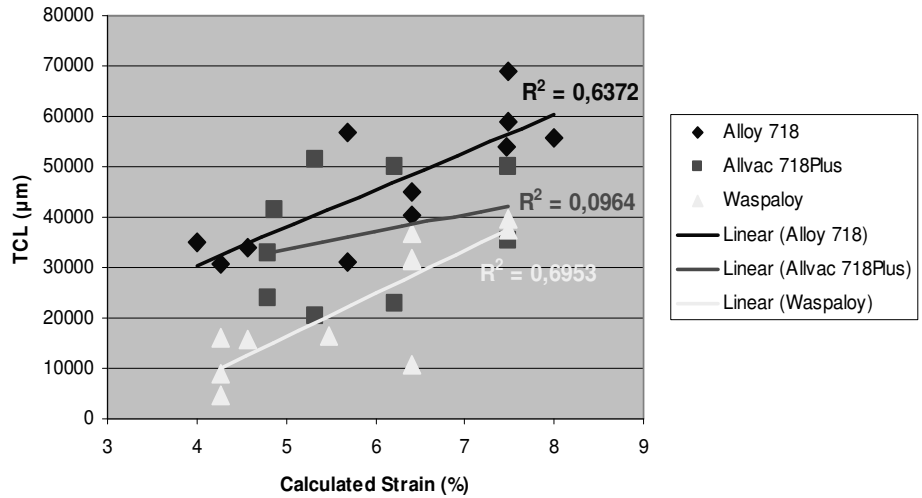
Figure 10: Vareststraint comparative testing results.

It is always arguable how the measured total crack length (TCL) can be practically utilized but by comparing with other alloys of interest a rating can still be made to assess “weldability”. Comparison by this testing was made with regular 718 alloy and Waspaloy, Figure 10. It is obvious that there is considerable scatter but still it is evident that Allvac 718Plus comes out at par with 718 alloy, which is known for its good weldability. In this testing Waspaloy is least prone to cracking which may be surprising since its weldability is usually considered as poor. However, this anomaly can be understood due to the post-weld heat treatment response in Waspaloy, which causes strain age cracking in Waspaloy. This is not likely in either 718 alloy or Allvac 718Plus due to the slow sluggish hardening response in these two latter alloys.

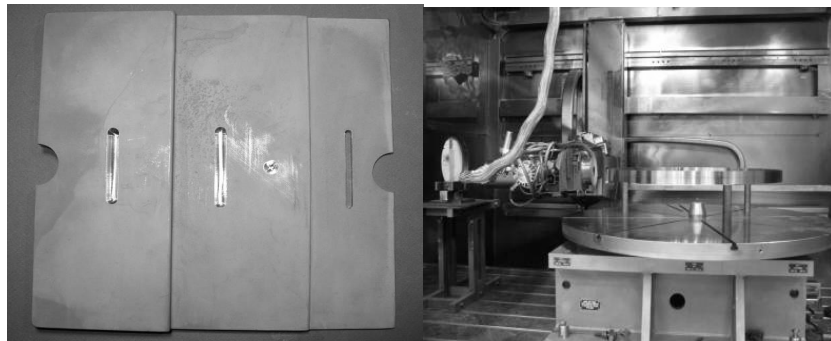
Figure 11. Weld repair setup cast 718Plus (left), and electron beam welding setup forged 718Plus (right).

To understand the potential of Allvac 718Plus for casting, weld repairability was assessed on the stair case shaped platecastings in which both thin and thick cross-sections could be evaluated, Figure 11.

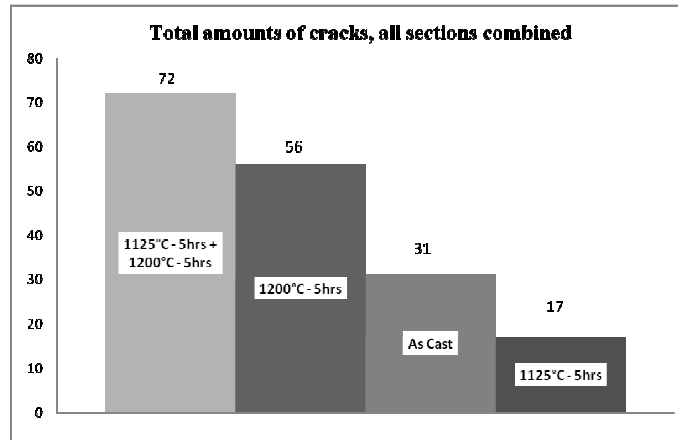
Figure 12. Total amount of cracking for each specific condition when all sections are combined is represented.

Results indicated that high temperature homogenization heat treatment such as 1200°C decreases the weldability whereas homogenization treatments at lower temperature such as 1125°C is beneficial for weld repair of cast 718Plus [9], Figure 12. The benefit of the latter one is ascribed to enhancement of the ability of backfilling since more eutectic phase constituents are present within the microstructure.

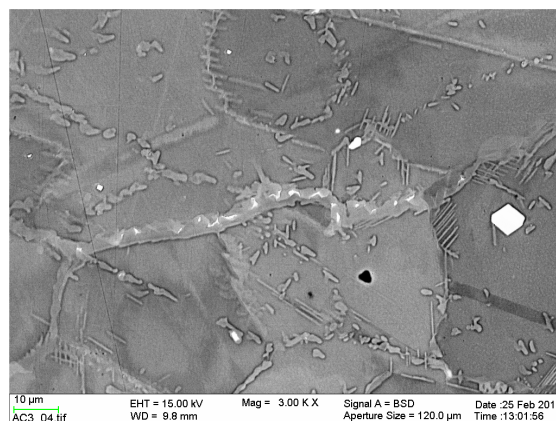
Figure 13. Backfilled crack during EB welding of forged 718Plus.

The EB welding trials were performed on three different thicknesses (6 mm, 12 mm and 20 mm) varying weld parameters such as welding speed, accelerating voltage and current [13]. Although a wide range of parameters were used, no cracks were found. Metallographic examination revealed that also here backfilling had an important role. It seemed like the δ phase promotes a Laves phase transformation through constitutional liquation which improves in healing cracks, Figure 13.

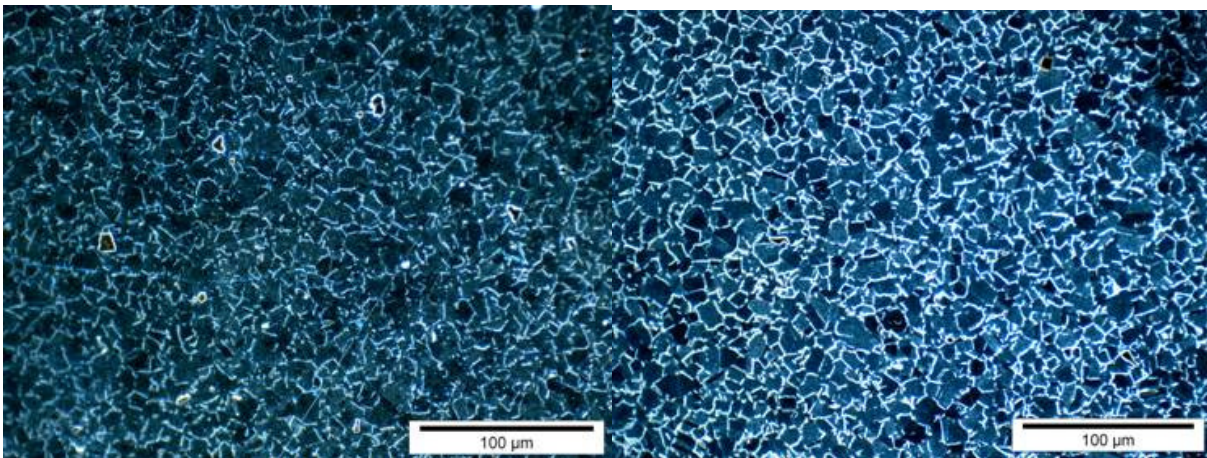
Figure 14: Micrographs of δ precipitation on wrought alloy 718 as heat treated (left), and after exposure at 700°C for 140 hours plus 675°C for another additional 460 hours (right).

Microstructural characterization was performed here, including determination of δ phase volumetric fraction by image analysis and application of ASTM E562-89 standard. As expected, percentages of δ phase increased significantly in regular 718 alloy, with values increasing from around 8% in the heat treated condition to over 17% in the exposed condition. Grain size, however, did not change with this exposure. This analysis was not performed for 718Plus, as mechanical properties were not degraded. Figure 14 shows the difference in δ precipitation for wrought alloy 718. It was observed that once the amount of precipitation is significant, the δ precipitation occurs not only along the grain boundaries, but also within the grains.

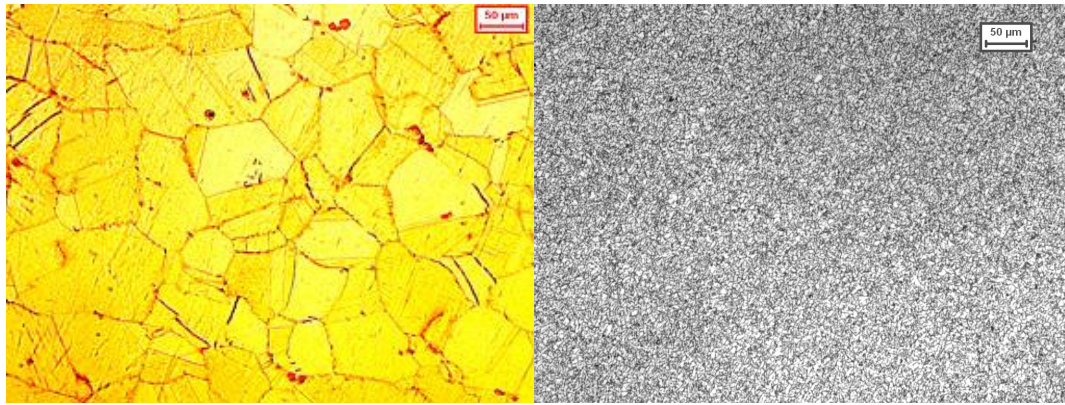
Figure 15: Micros of heat treated and exposed rolled rings thicker rings (1-A and 2) ASTM8 grain size, δ phase, (left), and thinner rings (3 and 4-B) ASTM5 grain size, no δ , (right).

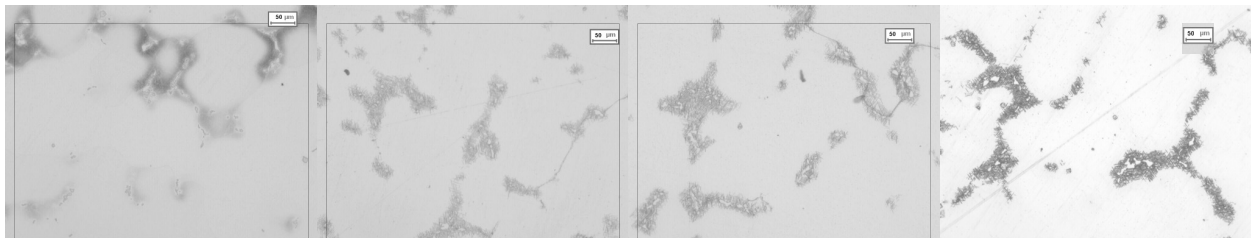
Figure 16: Evolution of cast 718Plus rings microstructures through different conditions, (left to right):

Homogenized at 1095°C, 1 hour and HIPed at 1120°C, 4 hours; previous after solutioned at 982°C, 1 hour; previous after aged at 788°C during 8 hours, air cool to 704°C, maintain 8 hours, air cool; previous after exposure to VITAL conditions.

For the cast material, however, the influence of exposure in the microstructural condition of the material was not so significant. This is observed through the microstructural assessment of the material in the different heat treatment conditions: as-cast, homogenised (if this was applied), HIPed, solutioned, aged and, finally, exposed. The detected changes (dissolution of Nb segregations, and precipitation of δ phase) are more pronounced in the first steps, at higher temperatures, than during the final exposure. Figure 16 shows an example of this, with details given elsewhere [11].

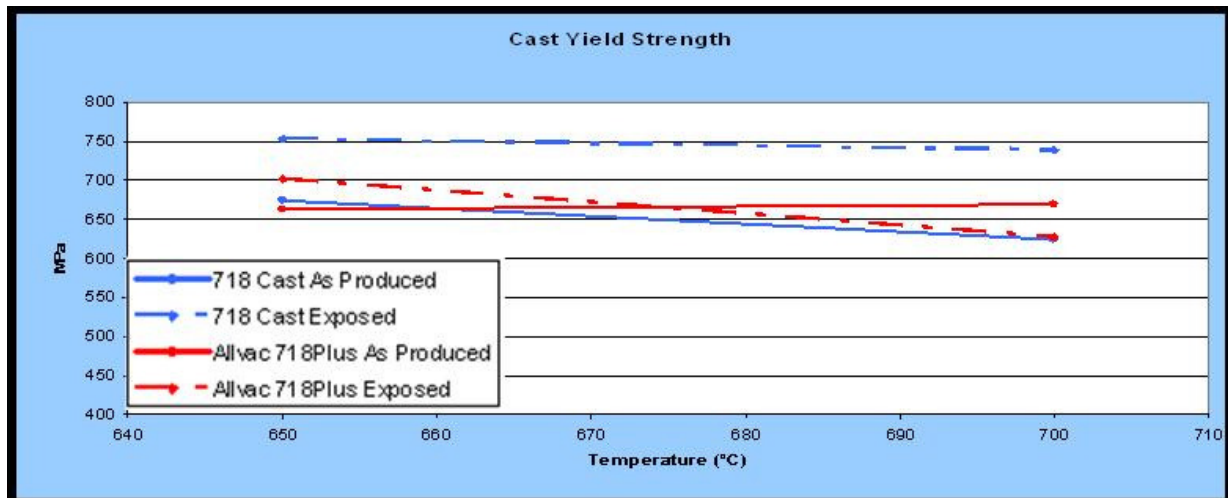
Figure 17: Yield strength of cast form of 718 and 718Plus at different temperatures, before and after exposure.

It has to be mentioned that results on casting forms of the alloys brought a couple of surprises. The regular 718 not only did not degrade its mechanical properties after exposure, but it did even improve them. This is contrary to all literature published up to date, though it is true that this literature rarely refers to cast material, but is mostly dedicated to the wrought form. This increase in yield strength for 718 after the exposure to high temperature can be noticed in Figure 17. It is consistent through the testing temperatures. A possible explanation for this is that the Nb retained in segregations that appeared in the rather thick section of the rings from where the samples were excised was freed through diffusion during exposure to form additional strengthening precipitates. However, this effect is not seen in 718Plus, which would make the explanation weak. But it has to be considered also that γ'' is not recognised as the main strengthening phase in 718Plus, so diffusion of Nb wouldn't strengthen it much further.

It is also surprising to see scarce, if any, advantage of 718Plus from regular 718, either before or after exposure. This might demonstrate that the chemical composition optimisation was still needed.

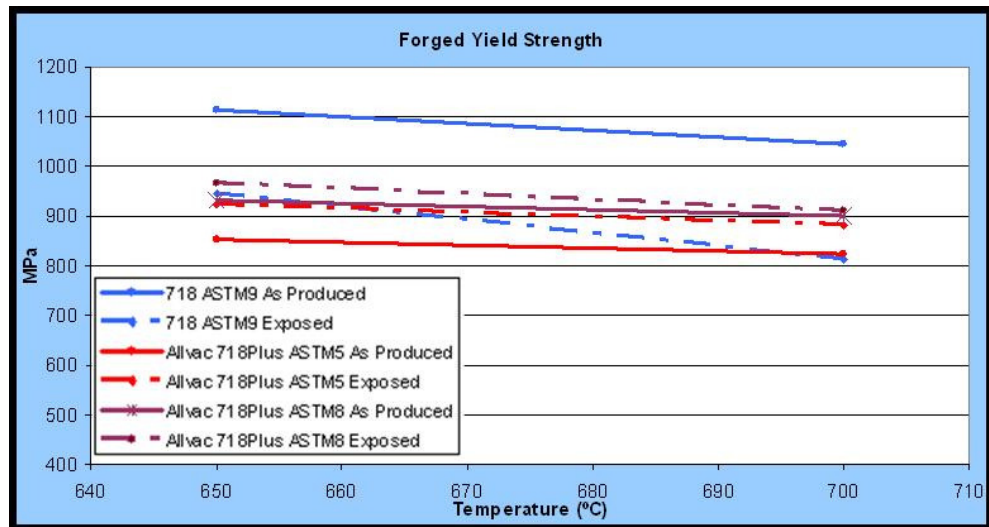
Figure 18: Yield strength of wrought form of 718 and 718Plus at different temperatures, before and after exposure.

Degradation in mechanical properties of regular 718 is clearly noticeable in Figure 18. Also note that the finer grain size of 718Plus presents better values than the coarser one. There is still another fact which will be mentioned afterwards, which is the larger response of the coarse grain 718Plus to the exposure, compared to the fine grain one. Whilst the fine grain material stays pretty stable, the coarser structure reacts positively to this exposure, improving yield strengths.

The higher yield strengths of regular 718 compared with 718Plus are partially attributed to the finer grain size of the regular 718 rings. The regular 718 ring has finer grain size (ASTM9, instead of ASTM8 for 718Plus ring), which, together with the non-optimal manufacturing route (and thus non-optimal microstructure) of the 718Plus rings, explains the advantage that can still be observed for the regular 718 rings. This higher strength of regular 718 at lower temperatures has also been noticed in other studies and publications from Allvac.

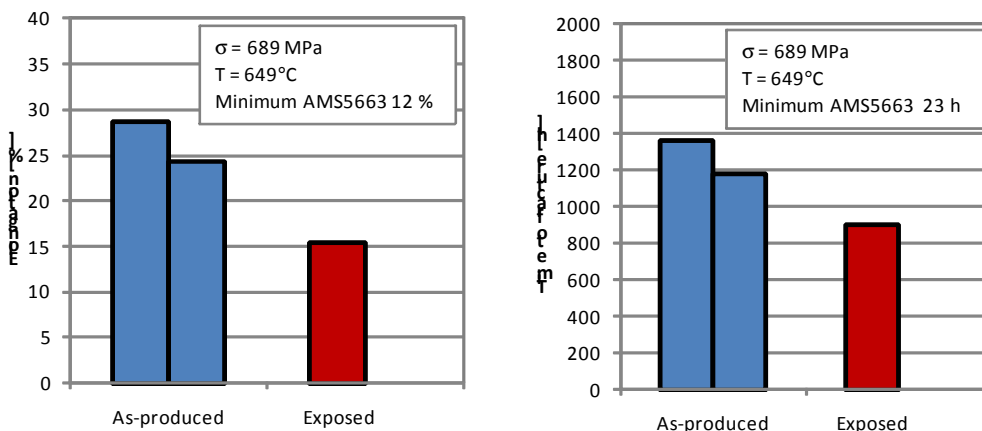
Figure 19: Stress Rupture of wrought form of 718Plus, before and after exposure.

Cast materials were not tested in this case. Stress rupture tests on smooth cylindrical specimens showed that both the time to fracture and elongation are significantly higher in forged 718Plus than those required by specification AMS5663 for 718, at 689 MPa and 649°C. Long time exposure, however, reduces both elongation and time to fracture but the values are still above the 718 specification. Even though the elongation decreases, so does the average creep rate (if approximated as elongation divided by time to fracture), indicating an improvement in the resistance to creep deformation with exposure.

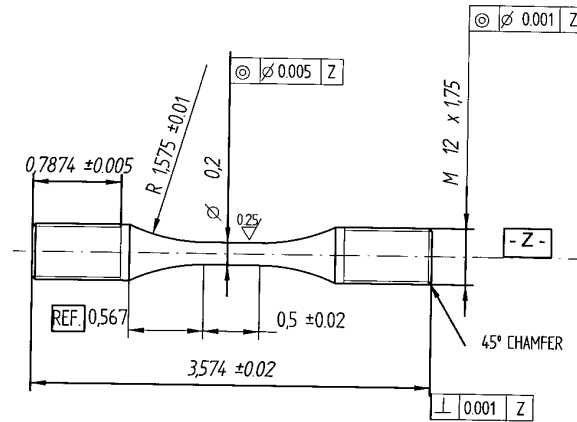
Figure 20: LCF test samples geometry.

For these tests, the geometry of tested samples was the one shown in Figure 20. All LCF samples were produced using low stress grinding for final surface finish.

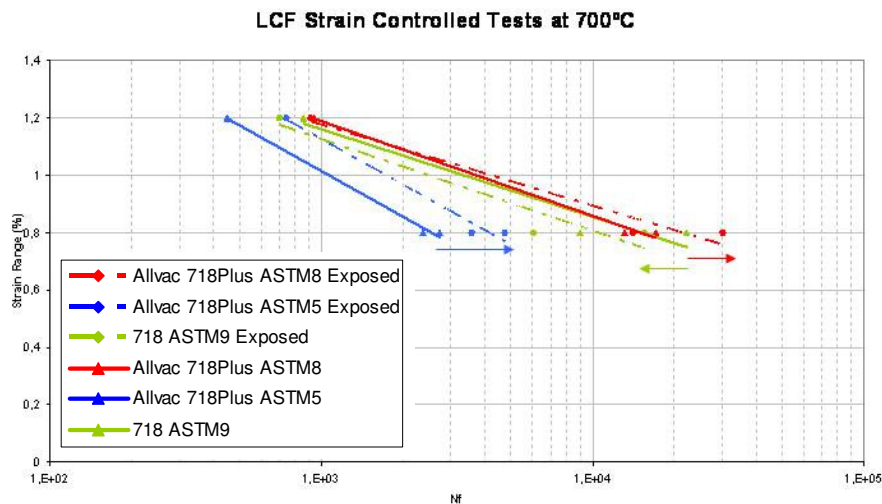
Figure 21: Low Cycle Fatigue properties of wrought form of 718 and 718Plus at 700°C, before and after exposure.

Regarding LCF, wrought 718Plus proved to be more resistant to thermal degradation than baseline 718 alloy. As was already reported in the tensile discussion, the 718 properties do significantly degrade when exposed to high temperature; this fact is confirmed and again supported here. What is now even more easily noticed is the improvement that the coarse grain 718Plus material has achieved after the exposure. This was more noticeable in tests performed at high temperatures, and is again consistent with previous results in tensile tests. A possible explanation follows. Given that, as mentioned in the “wrought material” section above, these particular pieces of material had received an extra heat during rolling operation which resulted in solution of the δ phase, the larger grain size material had only the capability to make the δ precipitate during the exposure of the material. This hypothesis does also consider that the coarser grain material offers a smaller amount of grain boundaries, where the δ phase preferably precipitates. The smaller grain size material had a much larger grain boundary surface, enough to precipitate all δ during initial heat treatment. If this hypothesis is considered, together with previous information from the “wrought material” section above, both together lead to the idea of a material more sensible to manufacturing conditions than regular 718 alloy.

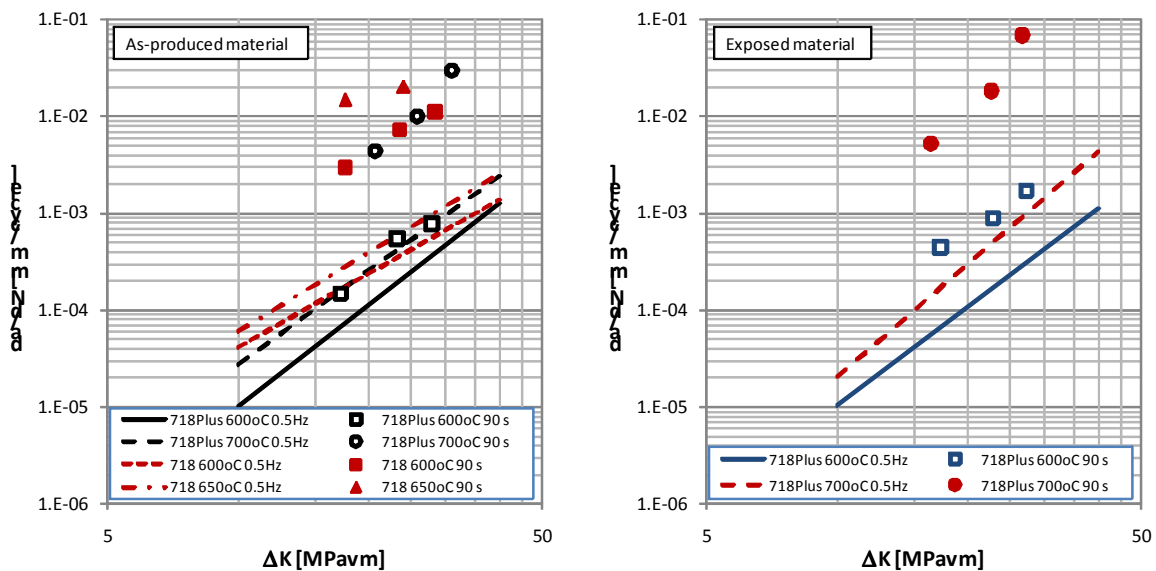
Figure 22: Crack Growth Rate tests of wrought form of 718 and 718Plus before exposure (left), and after exposure (right), including 90 seconds hold times.

Cast materials were not tested in this case. Crack growth tests were also performed at different temperatures and the results are reported in more detail elsewhere [15]. These tests did also include different conditions, with or without hold time being considered, from none to 90 seconds, to over six hours. 718Plus showed a behaviour dependant upon the testing temperature, with no hold time effect at 450°C, but with 10 times higher rates at 700°C when 90 seconds hold time is included. This effect grows exponentially when the hold time is increased to six hours. Comparison with 718 results show that, for the 90 seconds hold time, values of crack growth rate for 718Plus at 700°C are similar to those of 718 at 600°C. In other words, there is a 100°C advantage of 718Plus over regular 718, see Figure 22. After long time exposure, the resistance to hold-time fatigue crack growth decreased, whereas the cyclic crack growth rate was unaffected. The mechanism behind the reduced hold time crack growth resistance in the exposed condition is not clear at present, but the explanation can be assumed to be related to changes in grain boundary δ phase structure and development of the hardening precipitates. Hold time crack growth behaviour is also generally inversely dependent on the stress relaxation properties of the material. The crack growth tests were performed on coarse grained material, and the improved tensile properties after exposure, mentioned earlier, could be expected to reduce also the primary creep rate which would be detrimental to the hold time properties. This is consistent with the observed reduction in average creep rate above.
